**UPPER PASSAIC RIVER FLOOD CONTROL
LONG HILL TOWNSHIP, NEW JERSEY
N.Y. DISTRICT, U.S. ARMY CORPS OF ENGINEERS**

**APPENDIX E – DRAFT ENVIRONMENTAL COMPLIANCE &
COORDINATION**

# **Bog Turtle Habitat Evaluation and Phase II Presence or Absence Surveys for the Proposed Upper Passaic Flood Control Project in Long Hill Township, Morris County, New Jersey**

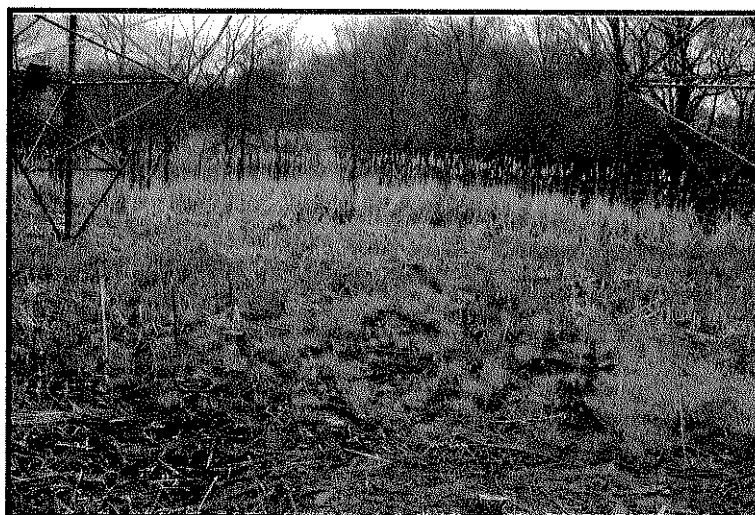
**Figure 2.** This photo, taken during HA's Phase I evaluation on April 28, illustrates an area of potential bog turtle habitat. Photo: Matthew P. McCort, Herpetological Associates, Inc. 2003.

During the April 28, 2003 habitat evaluation (Phase I), HA observed wetland characteristics that were consistent with potential bog turtle habitat (Figure 2). Many areas, all of which are along the powerline right-of-way, were wet with 2 to 6 inches of surface water. In addition, there were several channelized drainage ditches at various locations on the right-of-way (Figure 3). The surface substrate was mucky with an underlying clayey base. These observations led HA to rank the site as **3 Marginal** and recommend a Phase II presence or absence survey (Table 1).

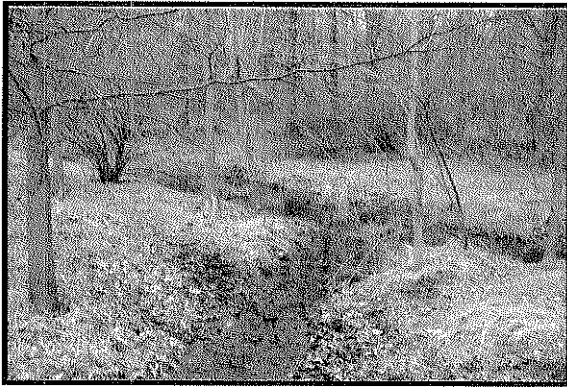
**Figure 3.** Photo showing habitat. This feature is a channelized swale that funnels water off of the right-of-way. Photo: Matthew P. McCort, Herpetological Associates, Inc. 2003.

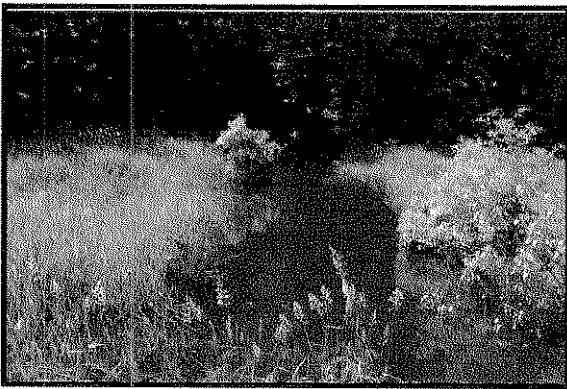
**Figure 5.** Photo, facing southeast, showing the channelized drainage ditch that crosses the right-of-way in the southwestern portion of the site. This feature became inundated with water after the Passaic River flooded in June. Photo: Matthew P. McCort, Herpetological Associates, Inc. 2003.

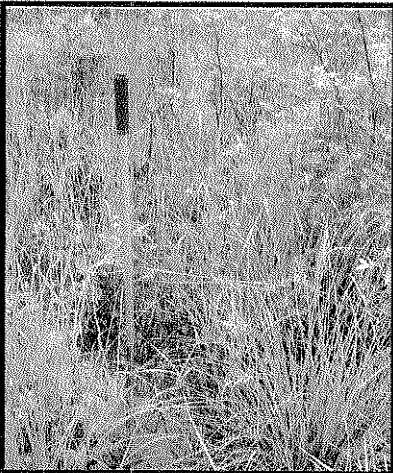
**Figure 7.** Photo showing broom handle (turtle stick) buried in 12 inches of water. Although there are indicator vegetative species present the overall conditions are not suitable for bog turtles. Photo: Matthew P. McCort, Herpetological Associates, Inc. 2003.

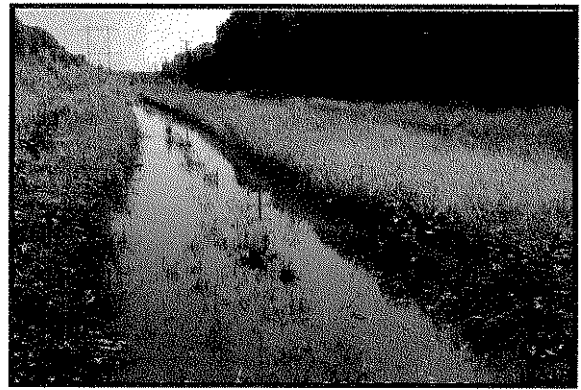
**Figure 4.** Photo showing the high water level from the flooding of the Passaic River. The feature shown is a gravel access road that runs under the powerline right-of-way along its length. Photo: Matthew P. McCort, Herpetological Associates, Inc. 2003
